Computers and Electronics in Agriculture

Original papers

Defect detection performance of automated hardwood lumber grading system

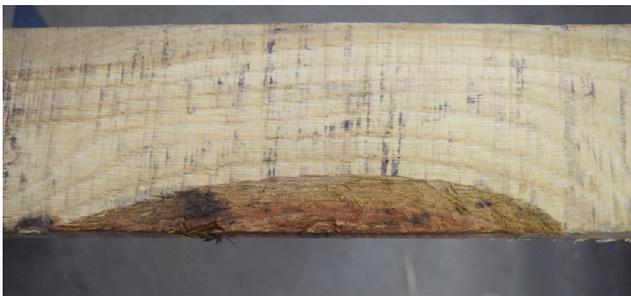
Fig. 1. Wane on white oak board.

Wane is the most common defect in high-grade lumber because it occurs on the outside of the log, near the clearest wood (Fig. 1). Defined as bark or the absence of wood on the edges or surface of a board, it is limited in both length and width allowed in upper grades of lumber, Select and Better (NHLA, 2015). Wane is considered unsound and not allowed in any cuttings. Profile cameras and lasers are the most important sensors in detecting wane. The threshold set for wane detection was for the cameras to identify anything that was greater than 1/32 in. in from the edge of the board but in general approximated to 1/8 in. to avoid false alarms caused by irregular edges. The reason for this is that by setting a threshold closer to the edge too much noise is picked up resulting in over estimate of wane length. For example, some species like hickory may have a coarse or stringy type appearance on the edge of the board because of the nature of the wood fibers or the saw tooth making the cut did not have a sharp enough edge. The threshold for wane width measurement also took careful adjustment and calibration because a certain amount of the wane would be surfaced off the rough lumber. Wane detection using the profile cameras and line lasers was very accurate and there was no single specific species that had a problem with wane detection. Wane can be on either face of a board, and on either edge of a face. It can be continuous, or broken into many sections. In the whole sample of 9454 boards, wane was detected 9366 times. The average wane length was 18" and average width 0.35". No boards were mis-graded because of wane detection.

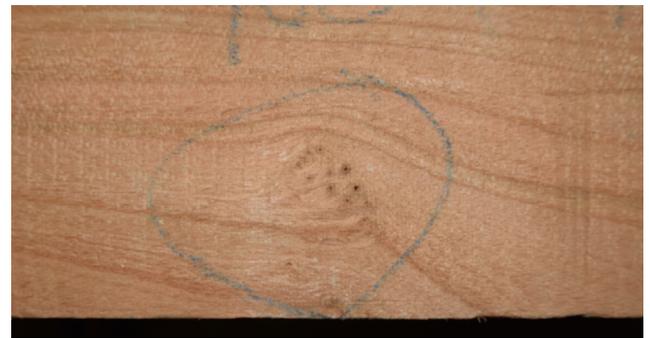
Fig. 4. Knot cluster in cherry board.

The last category for knots that were incorrectly identified would be knot clusters. The detection of knot clusters was excellent. Only four boards out of the 725 were graded incorrectly because of improper knot cluster under detection. Cherry as a species is notorious for knot clusters, formed by many small epicormic branches on the log surface. The NHLA grading rules do allow for any small knots less than 1/8th inch in diameter to be allowed in clear cuttings for cherry lumber, as well as any gum streaks or spots (NHLA, 2015). There were three instances where cherry boards were incorrectly graded because of under detection on knot clusters. For example, in cherry, being able to distinguish a clump of gum spots from a knot cluster was the give and take balance between detecting too much and not enough.

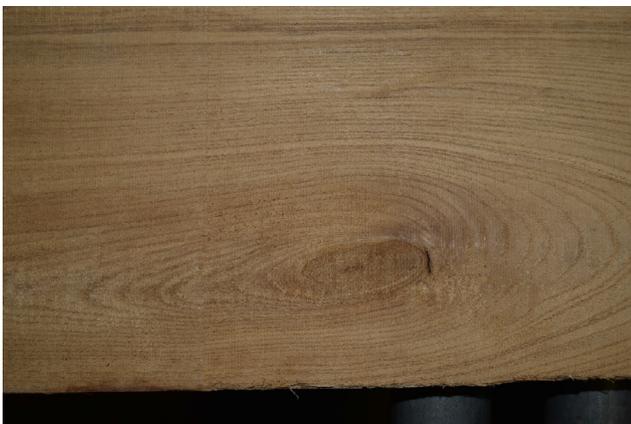
Fig. 2. Large pale knot in ash board.

Knots are very diverse lumber defects, both between species and within (Figs. 2–4). They are the result of a branch forming in the tree and growing out from the main trunk. Due to wood cells oriented often perpendicular to the face of the board, the fibers are more likely to split when drying and have a different density compared to the normal wood surrounding (Denig et al., 2000). Often, knots will have a darker color or be surrounded in enclosed bark, resulting in a loose or unsound knot

Large pale knots are the knots that have the same color as the surrounding clear wood. These knots are difficult for the color cameras to detect because of the lack of color difference between the knot and surrounding clear wood. Large knots are particularly challenging defects to detect also because as the branch gets bigger, its density and grain deviation surrounding the knot are homogenized and increasingly appear like normal clear wood. Lasers and scatter cameras could identify the crack in the middle that forms across a knot after it is dried, and cuttings were not placed over a large split. It can also be challenging for human graders to decide how far into the pale knot a cutting can be placed, if at all. Out of the 725 boards that were incorrectly graded in the study, 110 were a result of under or partial detection of large pale knots.

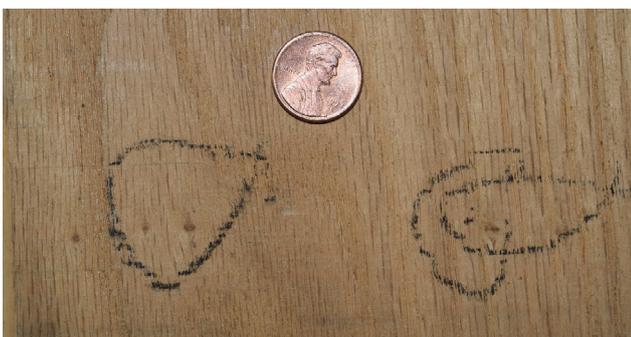
Fig. 3. Pin knots in red oak board.

Another type of knot that was a challenge for the scanners detection capabilities was classified as a pin knot, or small black knots, less than 1/4-inch diameter. Ash and basswood were a particularly challenging species because of the lack of density changes in the knots. The color cameras were able to detect a change in color for these knots, but due to the small size, there often was not enough change in density for the x-ray machine to confirm the presence of the knot. Without defect confirmation from the x-ray, these small knots were dismissed as either a smudge of dirt, grease or another visual surface blemish but not a

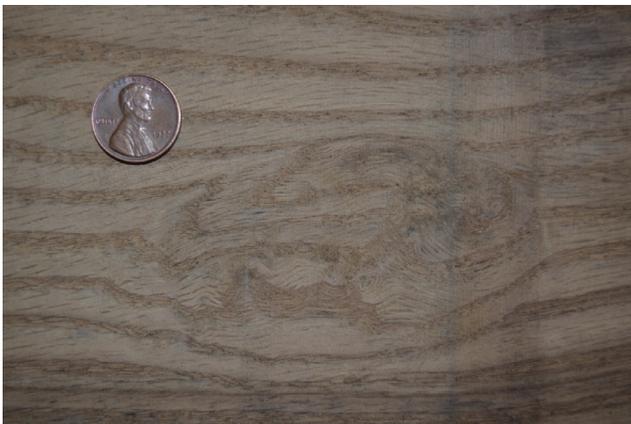
Fig. 5. Burl detected as a knot in red oak board.

The largest error for over detection of defects was in the category of false knots. There were 106 boards out of the entire study sample of 9454 boards that were graded in-correctly because of a false positive knot detection. The main causes for this over detection are burls, which would be a swirling of the grain near where a knot would form (NHLA, 2015). The scanner would identify these burls as knots because of the irregular grain pattern and fiber deviation being identified by the laser systems and the increased density detected by the x-ray, because commonly there was a knot just below the surface (Fig. 5).

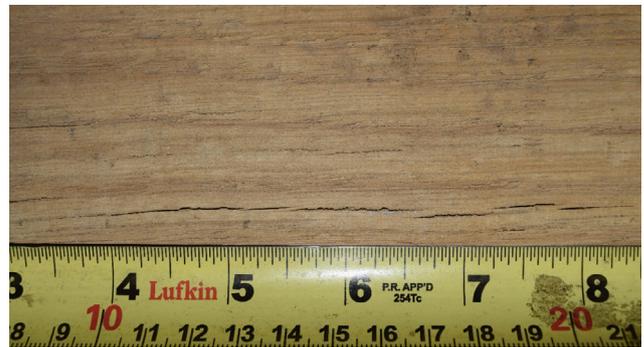
Fig. 6. Surface checks in white oak board.

(Fig. 6). Wood cells shrink during drying and as result of this loss of moisture, small cracks appear (Denig et al., 2000, Wengert, 1990). These checks can be on either the surface or end of a board. For grading purposes, normal season checks that can be surfaced out of lumber at standard surface thickness are acceptable in clear cuttings (NHLA, 2015). The detection of surface checks splits and cracks was extremely accurate. Any separation within 1/64th of an inch could be detected, but this level of detail did generate some false positives particularly when a board had an extremely rough surface or fuzzy grain appearance. In species such as red oak and yellow poplar, the level of precision on the scanner was adjusted to only identify separations of greater than 1/32nd of an inch to limit those false positives.

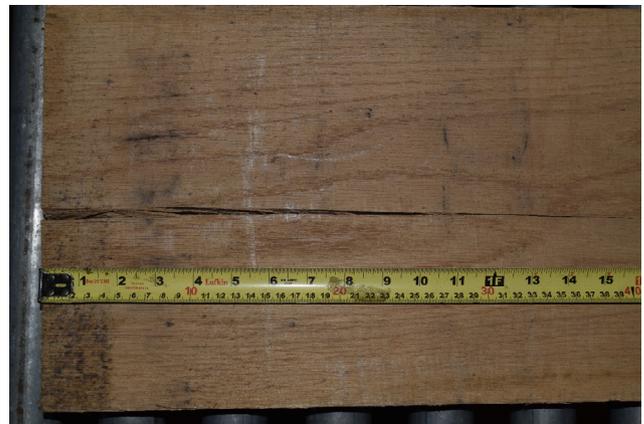
Fig. 7. Split in white oak board.

Splits are detected the same way as these ordinary season checks with the laser triangulation. Both the vertical and profile cameras are responsible for seeing how the laser reflects. Large splits, separation of wood that goes all the way through a board starting from an end, especially need the profile camera for accurate detection because the laser will not reflect as there is no material to reflect upon (Fig. 7). The scanner handled split and check detection exceptionally well, to the point where surface roughness of boards, where the normal rough grain surface was mistaken for a check or split resulted in 68 boards being graded incorrectly as a result. In the whole sample of 9454 boards, the splits and checks were detected 18,987 times. The average length was 1.95" and average width was 0.15".

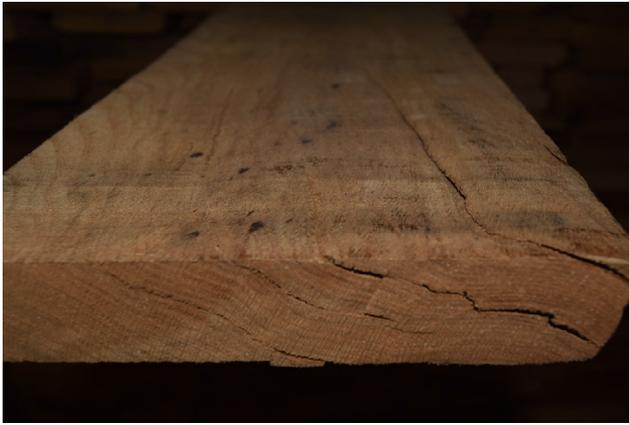
Fig. 8. Shake in red oak board.

Shake is a separation along the grain of a board between the annual growth rings and is considered an unsound defect (Fig. 8) (NHLA, 2015). Bacterial infection in the wood that weakens the early wood is most often the cause of ring shake, but wind throw from large storms can also result in the separation of the growth rings. Drying lumber does not cause shake, but can exacerbate its presence (Denig et al.,

Detection of ring shake is mainly done with the lasers and both profile and black and white cameras. Similar to detection of a surface check, the scanner is accurate at picking up shake when there is a crack on the surface of the board. The majority of the incorrectly graded boards with shake detection as a reason had only partial detection and placed a cutting on top of the portion of the board with the shake not breaking through the board surface. Another reason for incorrectly identifying shake was that the grain separation was not perpendicular to the face of the board but rather at a bigger angle following the growth ring. Instances when the shake did not result in a 1/16th inch or larger separation on the board surface, detection was significantly hindered if the split was angled because it was too sharp an angle for the profile cameras to “see inside”. Out of the 725 boards graded incorrectly, 30 were the result of under detection of shake.

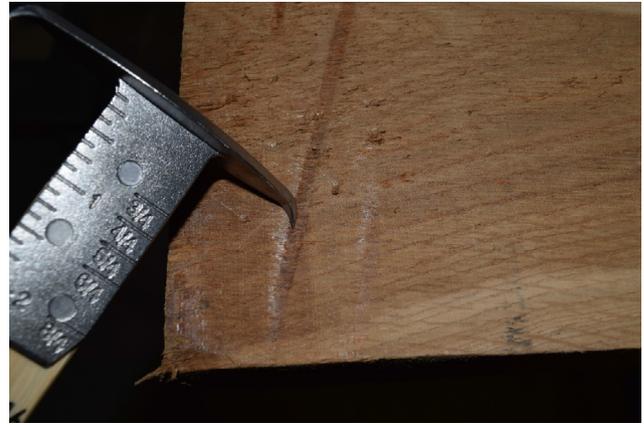
Fig. 10. Rot in red oak board.

Rot, or decay, is the fungal breakdown of wood cells (Fig. 10). There is a large spectrum of rot ranging from very advanced dry rot in which wood crumbles to the touch and white rot that is soft and spongy to incipient decay where the fungus is just starting to spread into sound wood cells (Hoadley, 1994, NHLA, 2015). Rot is difficult to detect for a scanner because of the minor color difference between the rot and normal clear wood. In rough lumber especially, incipient decay can closely resemble water stain. While lasers and color cameras struggle with detection of rot, while the x-ray can differentiate some changes in density if the rot is advanced. However, incipient decay that is starting to form, does not have enough density change to be detected consistently and as result cuttings were placed over rotten portions of the board. Ash was the most common species to have difficulty with rot under detection and this makes sense given the amount of standing dead trees starting to decay due to Emerald Ash Borer. The other feature of ash making incipient decay difficult to detect is that the decay looks very similar to the brown heartwood. In total 29 boards were graded incorrectly because of under or partial detection of rot, 24 of these boards were ash.

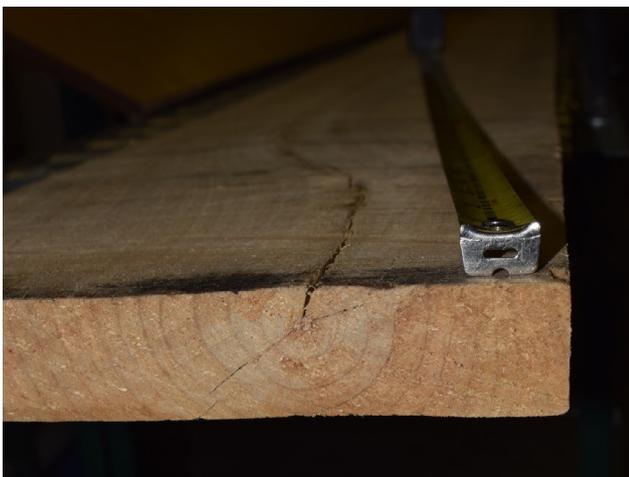
Fig. 9. Pith in soft maple board.

Pith is the soft core at the center of a log (Fig. 9) (Hoadley, 1994) and is regarded as an unsound defect in the NHLA grading rules (NHLA, 2015). It is subject to extreme shrinking problems due to the proximity of juvenile wood. For upper grades of lumber that come from the outside portion of a log it is seldom an issue, but can be, when sawing closer to the center of the log. Often times the pith is never sawn into boards because the log defect core in the center of the log is made into either a railroad tie or a pallet cant. Higher value species where the

The scanner could accurately detect the pith when it broke the surface of the lumber, using both lasers and color cameras. Pith is also known as boxed heart if it is enclosed within all four board surfaces (NHLA, 2015). Boxed heart was often partially detected with the lasers and cameras able to pick up the surface of the board cracked from shrinkage. The grading errors that occurred due to pith or boxed heart detection were a result of cuttings placed over areas where the surface of the board was not cracked open and the pith was hidden. The x-ray was not able to pick up enough of a change in density from the less dense pith core. Ash, cherry and soft maple lumber species had the most occurrences of pith under detection. Partial or under detection of pith resulted in 29 boards being graded incorrectly.

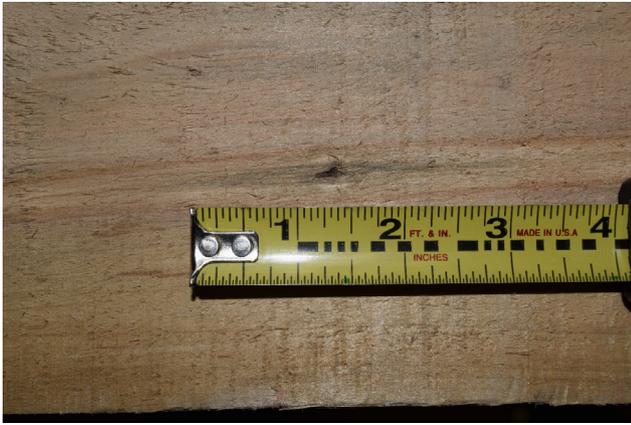
Fig. 11. Worm hole in soft maple board.

NHLA lumber grading rules describe any worm holes in lumber based on the average diameter of the hole itself. A pin worm hole is anything less than 1/16th inch in diameter, a spot worm hole is any hole between 1/16th inch to 1/8th inch in diameter and shot worm hole is a hole larger than 1/8th inch but smaller than 1/4 inch. Any worm hole that is larger than 1/4 inch in diameter is classified as grub hole. No worm holes are allowed in clear cuttings unless specified by the lumber order invoice as worm holes no defect (WHND). Pin, shot and spot worm holes are allowed in sound cuttings but grub holes are limited

Worm holes can create a challenge for detection, in being precise enough to identify very small details but also filter out false positives. If a worm hole diameter is less than one pixel size (0.19 mm or about 1/128"), there is a chance that it will be filtered out as a noise. Additionally, at higher speeds a worm hole can be missed because of sensor frame speed. From the nine species in this study, the two most common species to have boards graded incorrectly because of worm hole under detection were red oak and soft maple (Figs. 11–12). Unlike red oak, soft maple has gray or brown streak, also known as a flag, surrounding the worm holes. Because of this color feature, a special detection filter could be set where the detection sensitivity was increased and then any over detected worm holes not surrounded by a gray flag could be filtered out. Due to the drastic color indicator and this filtering technique, the worm hole detection in soft maple was considerably more accurate than in red oak. In the whole sample of 9454 boards, worm holes were detected 16,515 times. Out of the 725 boards that were graded incorrectly, worm hole under detection was responsible for 40 boards. The average diameter of a worm hole was 0.45 mm (0.018").

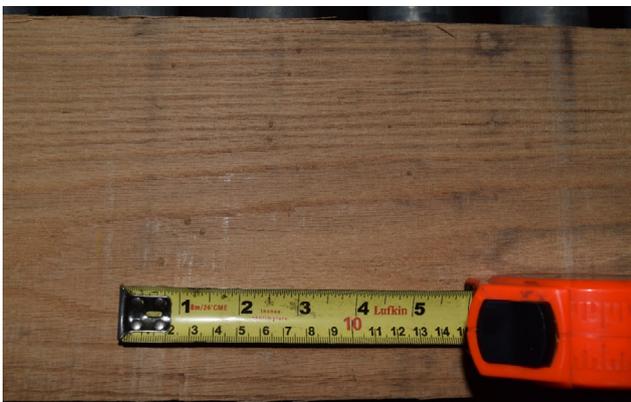
Fig. 12. Shot worm holes in red oak board.

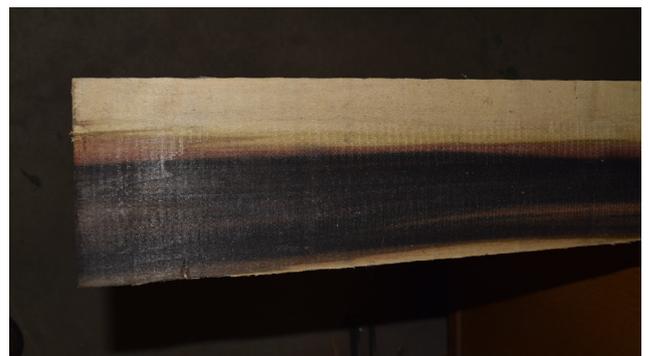
Fig. 14. Black mineral streak in yellow poplar board.

Other minor instances for grading errors included extreme mineral stain in yellow poplar boards that were a shade of black, much darker than the normal purple or olive streak (Fig. 14). Mineral streaks and spots can be limited in certain species such as oak and basswood based on the NHLA species specific rules. In the 13 instances of errors due to mineral streaks, most were extremely dark mineral in color that confused the laser systems and cameras so that a cutting would not be placed over the mineral at all. In the ash species, glass worm streaks that had included bark were confused with a bark pocket five times. The bark pocket detection on the scanner was very accurate in all species, including hickory, which has a lot of mineral, bird pecks, bark and other irregular features.
